# Manhole Inspection Summary

Manhole # S43C\_\_013MH

Insp Date: **4/13/08 1:30 PM**

**Location** Address: **Broadway**

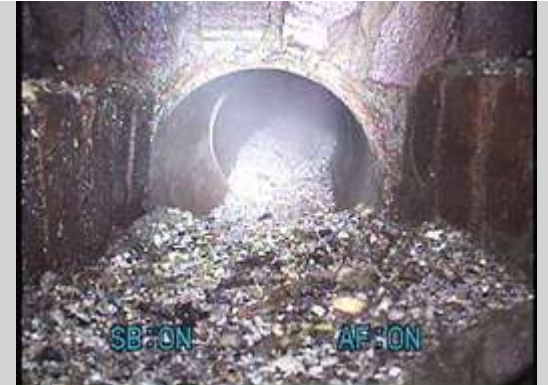
12 O'Clock Outflow

8 in. Circular Gravity Sewer  
Pipe Out @ 12 O'Clock

Pipe Material: **Clay** ☐ Pipe Lined

Invert Depth: **10.10** (ft.) Flow Characteristics: **None**

Deposits: ☒ None ☐ Mud ☐ Sludge ☐ Debris ☐ Grease

Infiltration: **None** Pipe Seal Cond: **Sound**

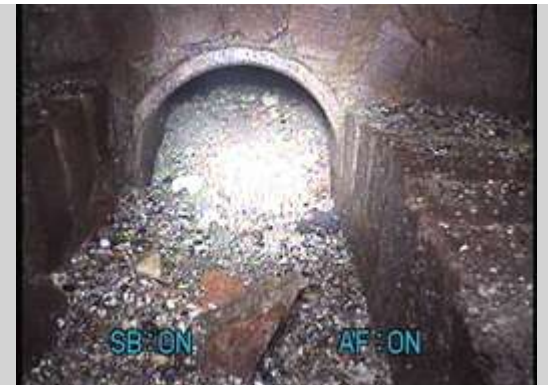
3 O'Clock Inflow

8 in. Circular Gravity Sewer  
Pipe In @ 3 O'Clock

Pipe Material: **Clay** ☐ Pipe Lined

Invert Depth: **8.10** (ft.) Flow Characteristics: **None**

Deposits: ☒ None ☐ Mud ☐ Sludge ☐ Debris ☐ Grease

Infiltration: **None** Pipe Seal Cond: **Sound**
